ANNUAL SITE INSPECTION REPORT

BAILEY SUPERFUND SITE ORANGE COUNTY, TEXAS

AUGUST 23, 1999

**PREPARED BY: BROWNING-FERRIS, INDUSTRIES
OF NORTH AMERICA**

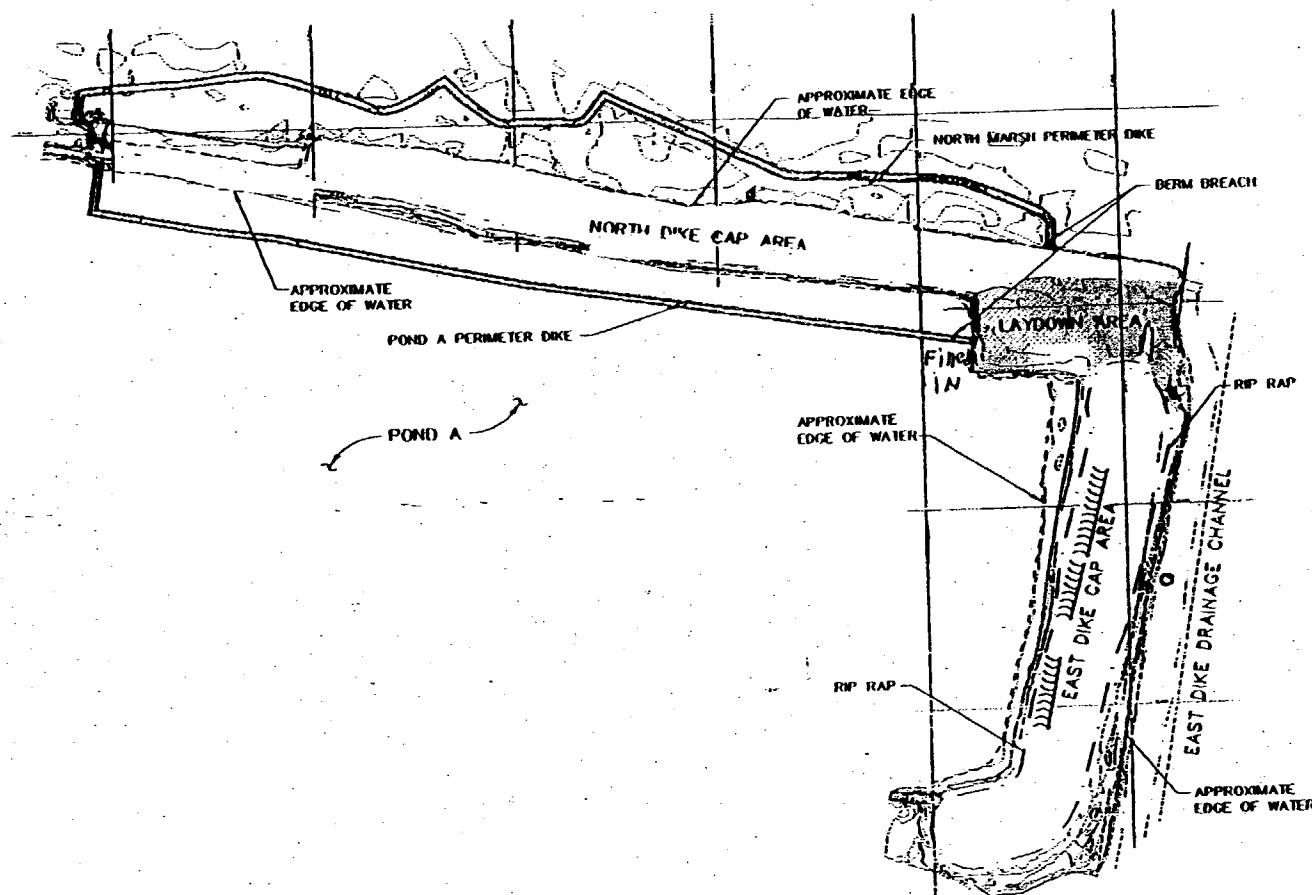
In general, bermuda grass growth at the site is vigorous, however, there were two areas where additional seeding was recommended: 1) along the northern edge of the north cap adjacent to the existing rip-rap, and 2) along the south end of the east cell. These were areas where vegetation was established, but additional seeding would be beneficial. All areas requiring reseeding were flagged during the August 23rd inspection.

Areas of concern observed during the August 1999 Annual Site Inspection included small areas of stressed vegetation located primarily along the north side of the North Dike and the southern end of the East Dike.

- 1.) Stressed Vegetation (TAN/SPARSE) located at various small plots along North side of North cell adjacent to Rip Rap, and at south west end of East cell. All locations flagged for reseeding.
- 2.) Bridge to be repaired & fence "wings" rewelded
- 3.) Sign fallen from fence east of East cell at mid point.

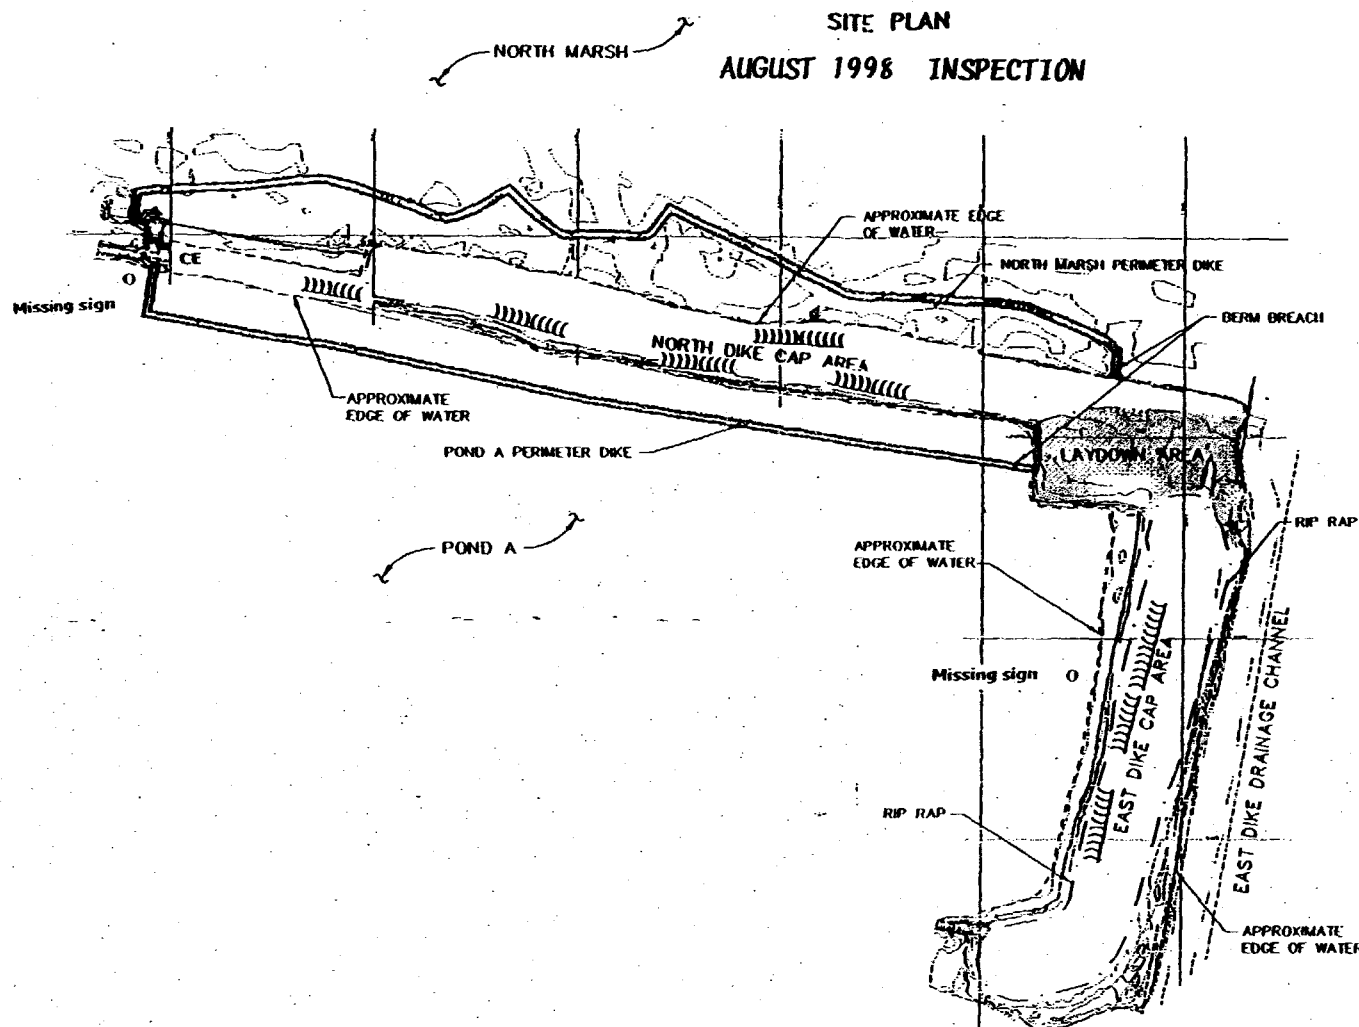
SITE PLAN AUGUST 1998 INSPECTION

The areas of differential settlement on the North and East Dike protective soil layer within the limits of the lightweight geosynthetic cap system.

The area of differential settlement in the rip-rap material located on the southcentral side of the North Dike.

Missing signs on the North and East Dike areas.

Road shell at west end of North Dike channeled due to rainfall runoff.

Place six inches of topsoil in areas where differential settlement was noted to occur. Reseed areas with bermuda grass or a bermuda/rye mixture, depending on growing season recommendations. Add fertilizer at the rates shown on the attached soil test report from the Texas Agricultural Extension Service.

Redistribute rip-rap material with a rubber tire backhoe to establish a consistent slope.

Attach existing signs to the applicable poles.

Eliminate erosion potential by spreading shell out with tractor boxblade and placement of fill in areas of differential settlement.

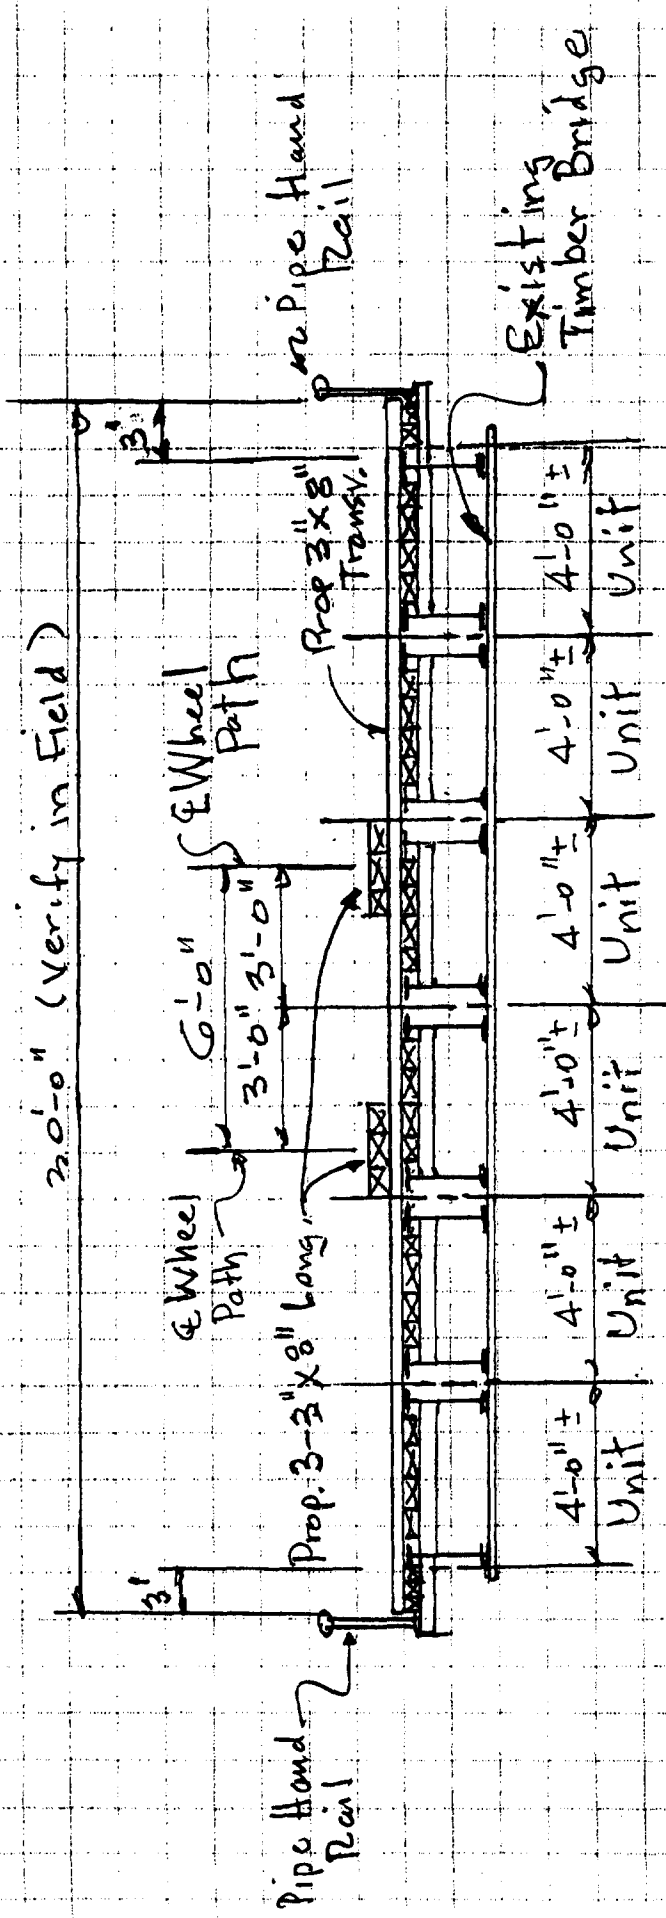
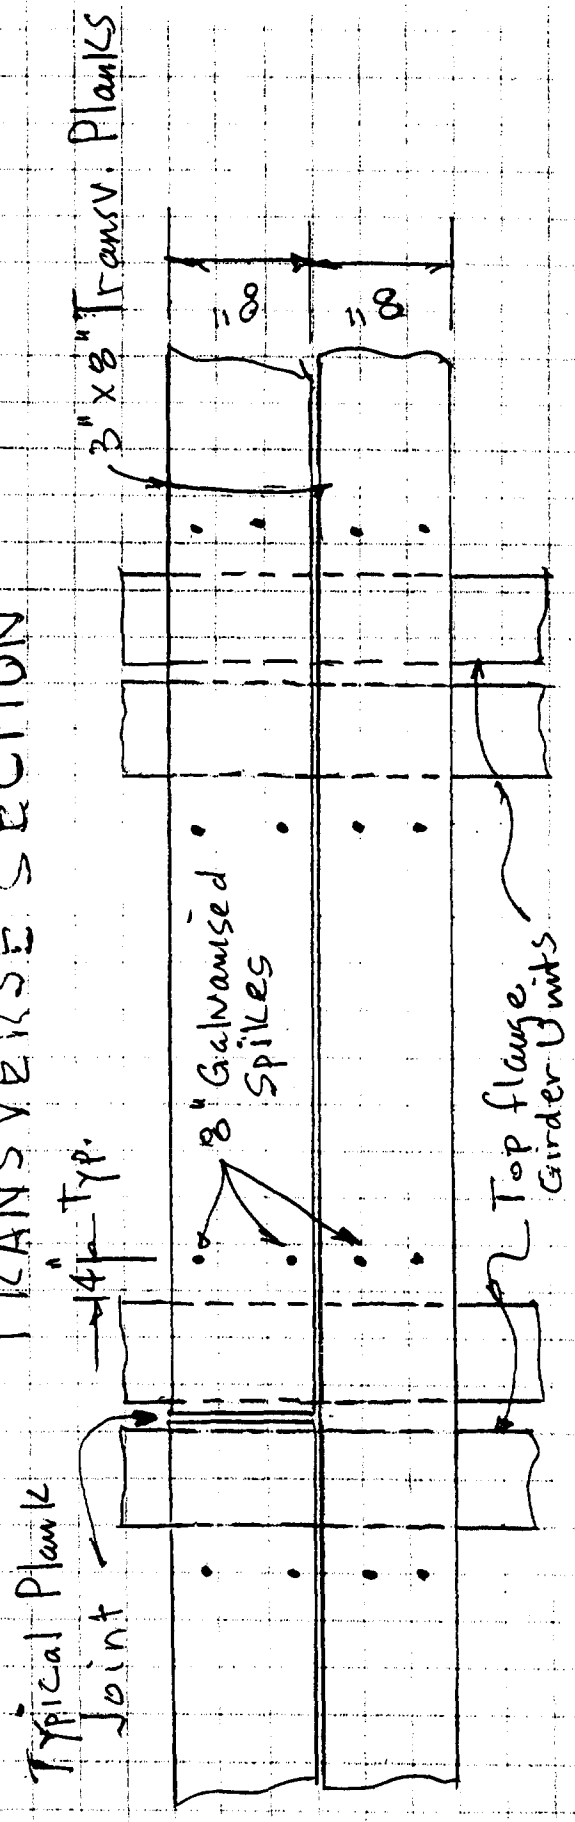
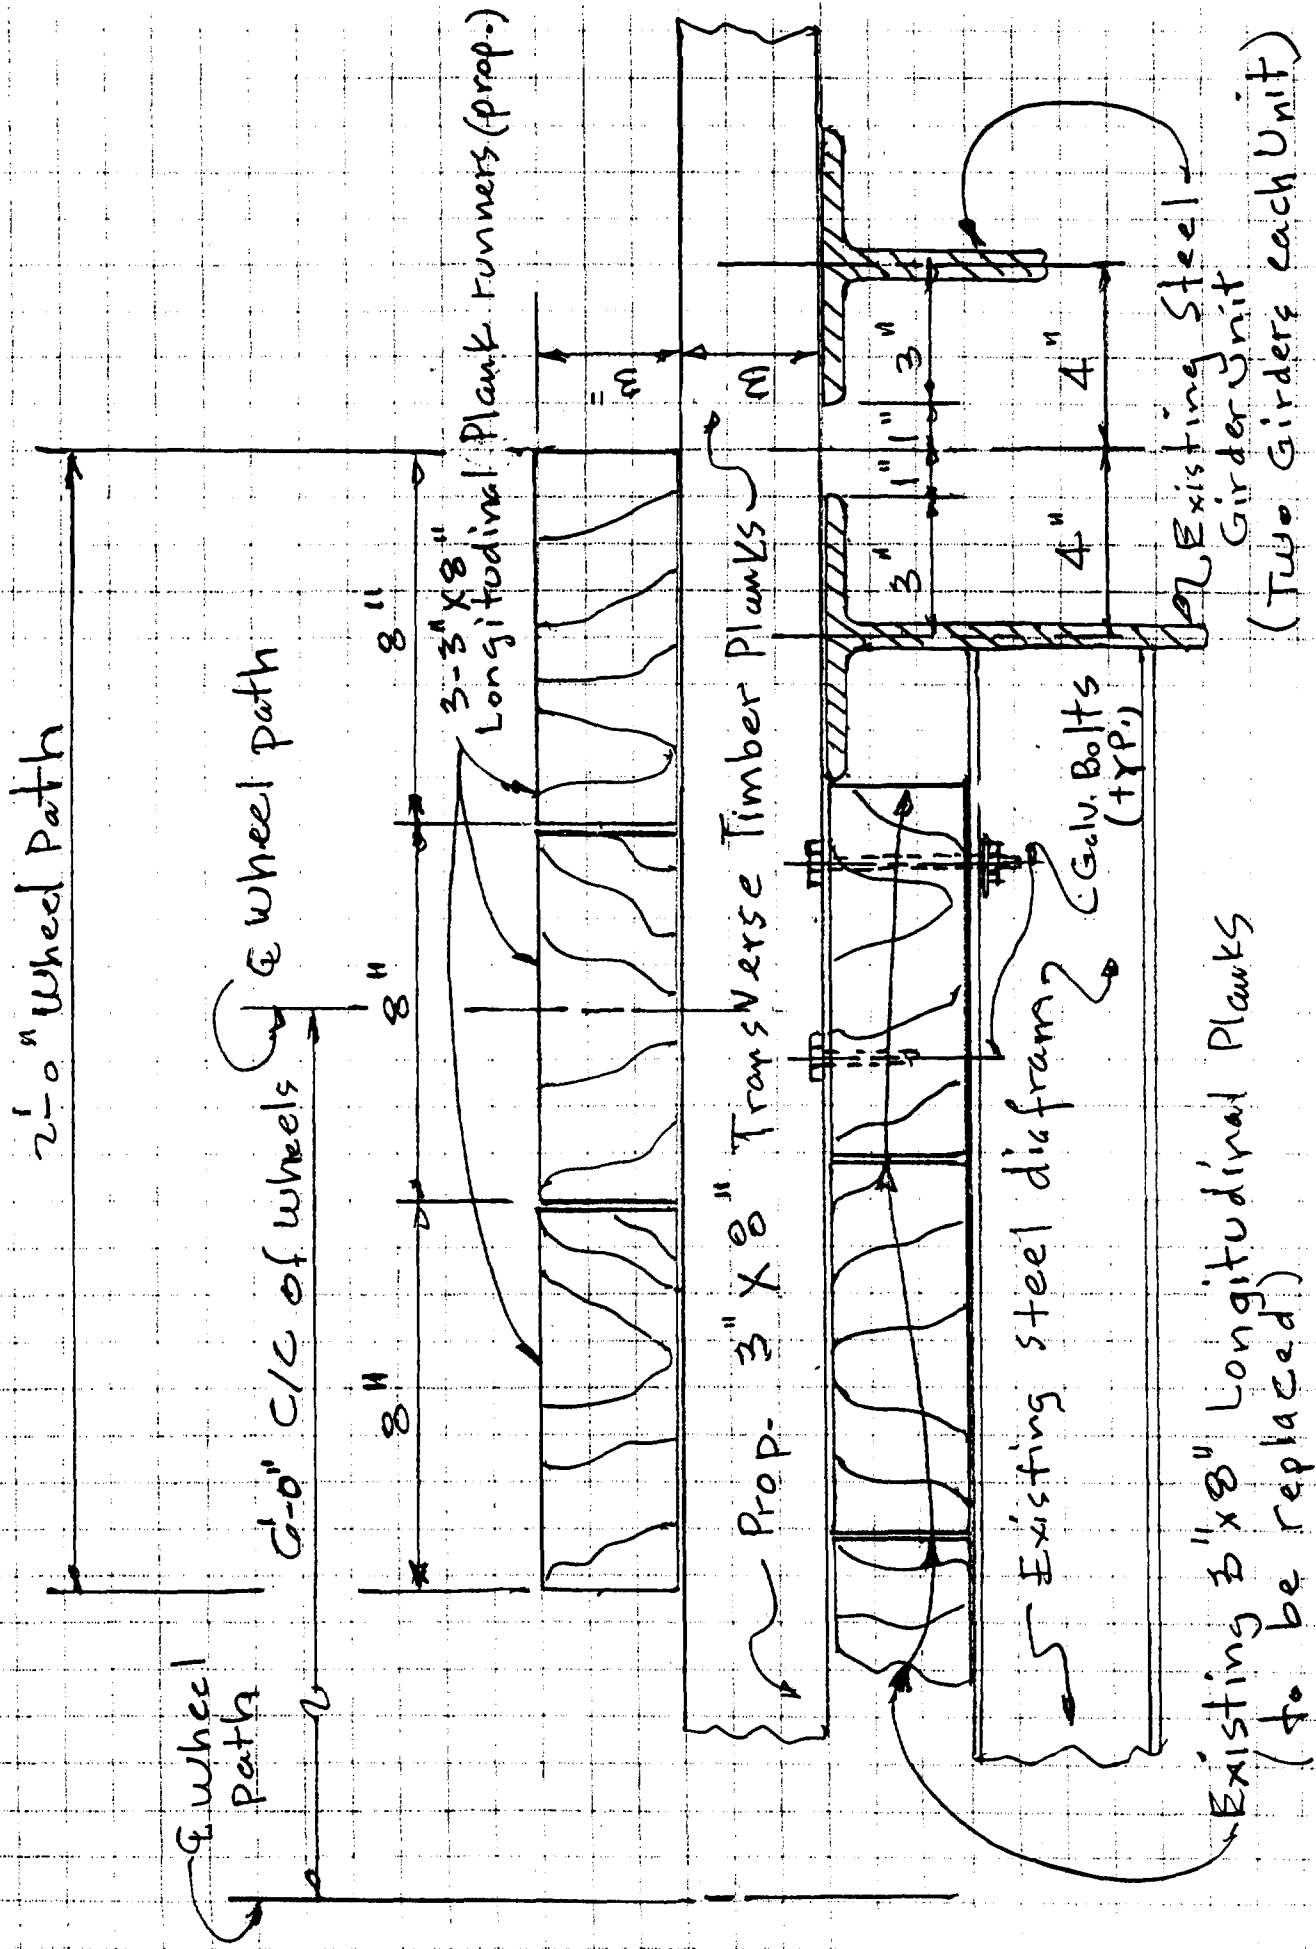
The site access bridge was previously inspected and found to be in need of retrofitting due to deterioration of the wooden upper decking. Please see Appendix E which provides a scope of work for the bridge repair. These repairs are expected to be completed before the end of October 1999.

Wood decking deteriorated - Contract to
retrofit bridge, handrails, etc. is pending.
See Appendix E.

In 1992, a single span bridge was constructed to provide construction access for remediation activities at the Bailey Superfund Site. The bridge consists of steel beam modular units with wooden decking. The bridge decking consists mainly of a double course of multi-ply wooden timber truck mats (typically used for oil field roads) secured to the bridge. Over time the wood decking has rotted and needs to be replaced. Proposals are requested for performing repairs to the bridge.

Provide all labor, materials and equipment necessary to perform repairs, remove and replace bridge decking as shown on the attached sketches and in conformance with the requirements for construction as presented below.

5. Upon approval of structural inspection, Contractor shall proceed with jacking bridge beams up and removing bearing timber beams that existing steel beams bear on at each abutment end. Contractor shall replace old timbers with new preservative pressure treated timbers in accordance with Item 492. Contractor may propose alternate options such as forming and pouring concrete in lieu of replacing old timbers with new ones. If Contractor proposes an alternate means, Contractor shall provide to the Engineer a submittal for approval providing details of concrete mix design, and reinforcement details.

6. Contractor shall provide and install new galvanized bolts for connection of timber planks to steel diaphragm members. Contractor shall provide new 8 inch galvanized spikes for connection of transverse timber planks to longitudinal timbers.

9. Transverse planks may be placed in lengths shorter than full width. Joints must be placed at the center line between adjacent girder units. Ends of planks must be supported by longitudinal steel girders. Plank joints must alternate. Transverse timber planks shall include sixteen feet (16- ft.) and eight feet (8- ft.) lengths or as approved by the Engineer.

10. Planks for longitudinal runners shall be a minimum of twelve feet (12- ft.) in length. Splice joints shall alternate for adjacent planks. A shorter length plank, in the center and at each end, shall be used to facilitate alternate joint construction.

11. Existing handrails that are damaged need to be repaired and rails need to be securely welded to the bridge structure. All existing handrails shall be coated with new epoxy paint (OSHA Safety Yellow color). Prior to coating surfaces, the surfaces shall be prepared in accordance with coating manufacture's recommendations and primed.
